National Register of Historic Places Registration Form

historic name Gehman, John Farm
other names/site number N/A

street & number Township Road not for publication
city, town Seisholtzville (Hereford Township) vicinity N/A
state PA code PA county Berks code 011 zip code 18062

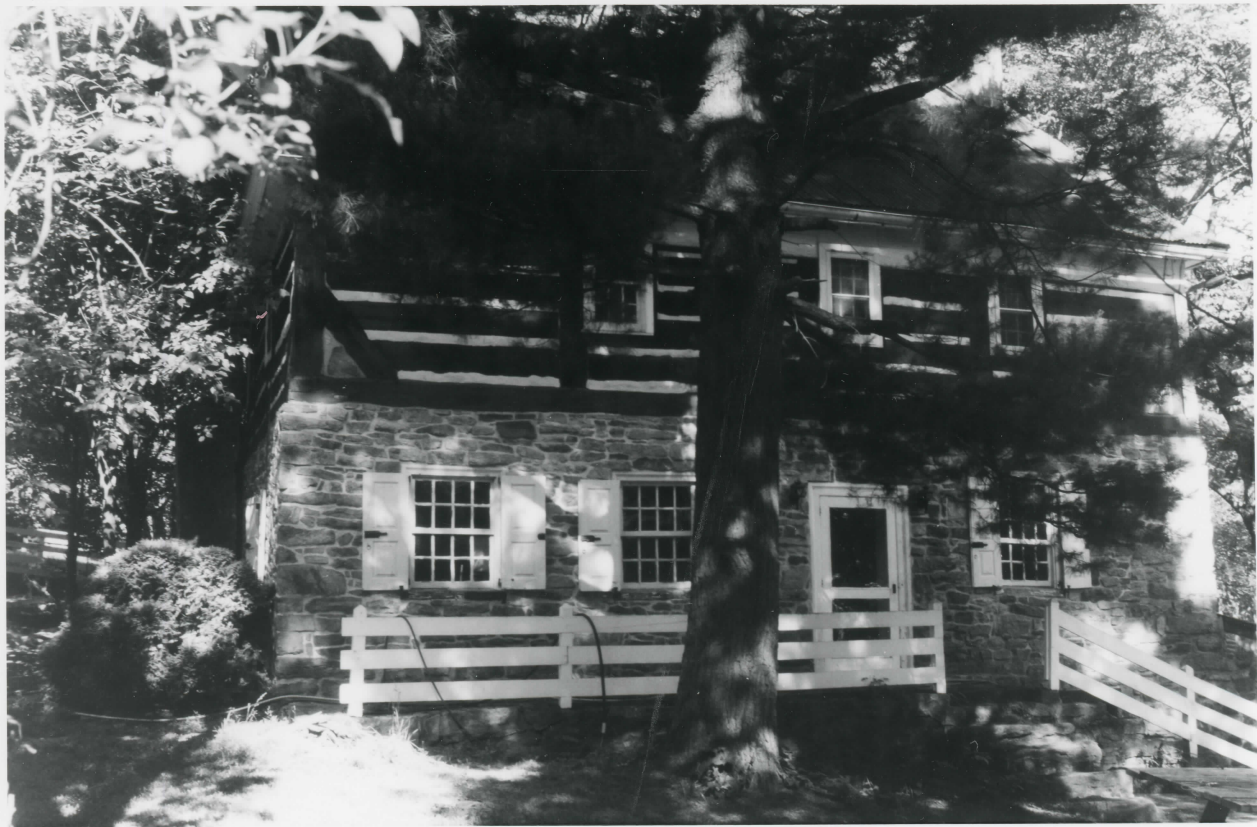
6. Swiss bank house, front facade, camera pointing NW
7. Photo #3

1. House: Swiss bank house, c.1767, 2.5 stories, stone basement and first floor level, braced corner post log walls on the second floor, kicked roof of shingles, open rafters, 8/8 and 12/8 window sashes, corner and end fireplaces, basement kitchen with end fireplace. Log walls exposed on three sides, with horizontal siding of wide beaded boards on north end. Log addition of 1970s of a combination kitchen-art studio matches earlier construction materials and does not detract from original. Addition has wood shake roof.

The Swiss Bankhouse type is actually a multi-purpose domestic building that provides for many functions in one building, such as cooking, washing and domestic chores on the lowest level, living area above, and sleeping chambers and grain storage on higher levels. Often exterior entrances are found at two or more elevations. In this example the stone basement is excavated into a steep bank so that it can be entered at grade level at the north end, and by cellar stairs at the south end. The basement level contains a large kitchen the full width of the house at the north end. It has a walk-in fireplace with a bee-hive oven opening in a back corner. It also has a large stone arched foundation support for the upstairs fireplace and chimney. To the rear are a several storage rooms and the stairway to the first floor. One of the unique features of this room is its open beam ceiling composed of hewn logs similar set only three or four inches apart. The interstices seem to be filled with stones and clay. Why such a massive support system was built for the floor above is a mystery. The first floor is entered from the east side and originally had a four room plan with no hall. The north east room has a large walk-in fireplace above the kitchen fireplace, while the southwest room has a corner fireplace at the outside corner. The house has wide board floors, open beam ceilings, and several original small built-in wall cabinets with paneled doors and original hardware. An enclosed winder stairway is located between the two back rooms. The upper level is the log portion, which consists of four rooms, and above that is the attic. In the 1970s the current owner built a one floor log addition, connected to the main house by a passageway from the back doorway of the first floor. The addition is built parallel to the house, offset to the north. Its use of compatible materials, and its separation from the house give it the aspect of a distinct entity that does not lessen the architectural significance of the original structure.

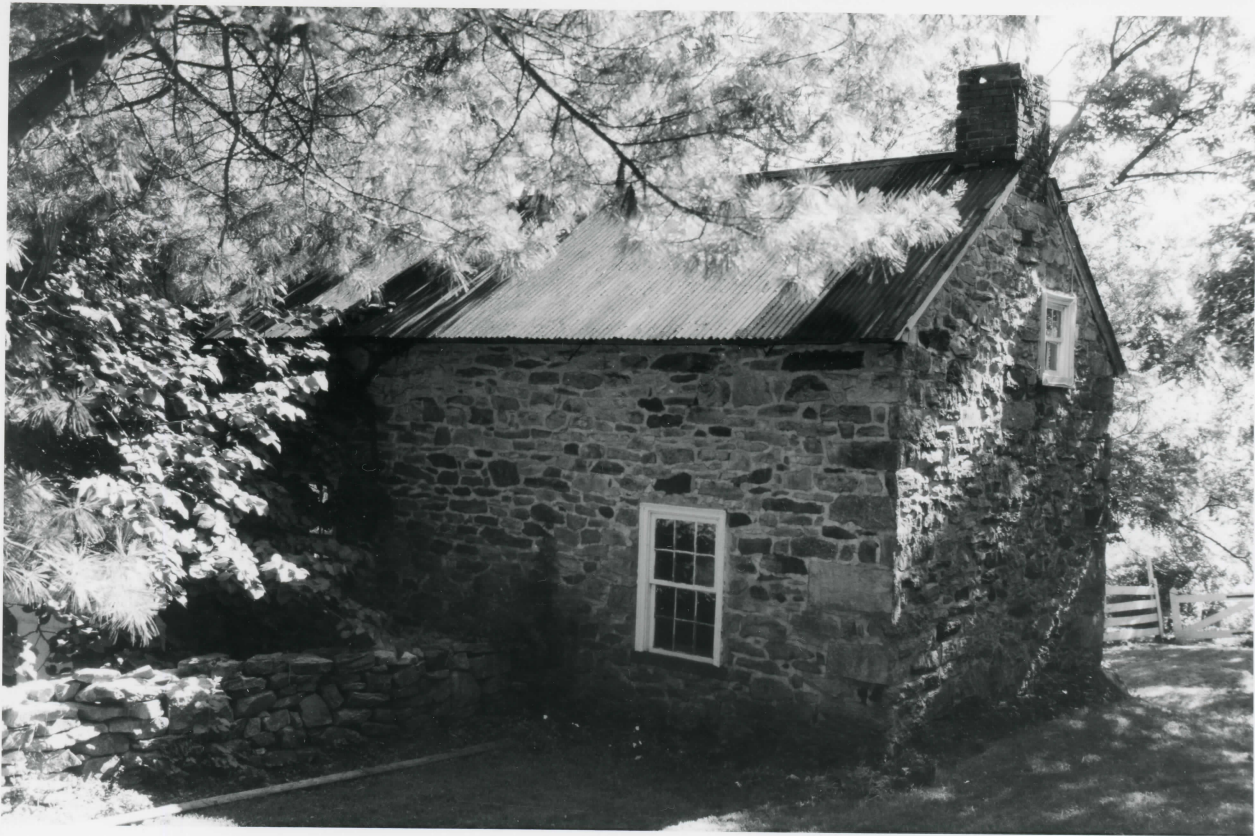
6. Springhouse view, camera pointing NE
7. Photo # 5

3. Springhouse: Banked stone cabin 1.5 stories, tin roof, datestone J. G. 1847. Half basement where spring channel existed now cemented. First floor room has built-in wall cabinet, walk-in fireplace at south end, rounded window reveals. Second floor had smokehouse room and attic. Walled spring is located to the east of the basement; formerly ran through cabin, now is piped to stream.

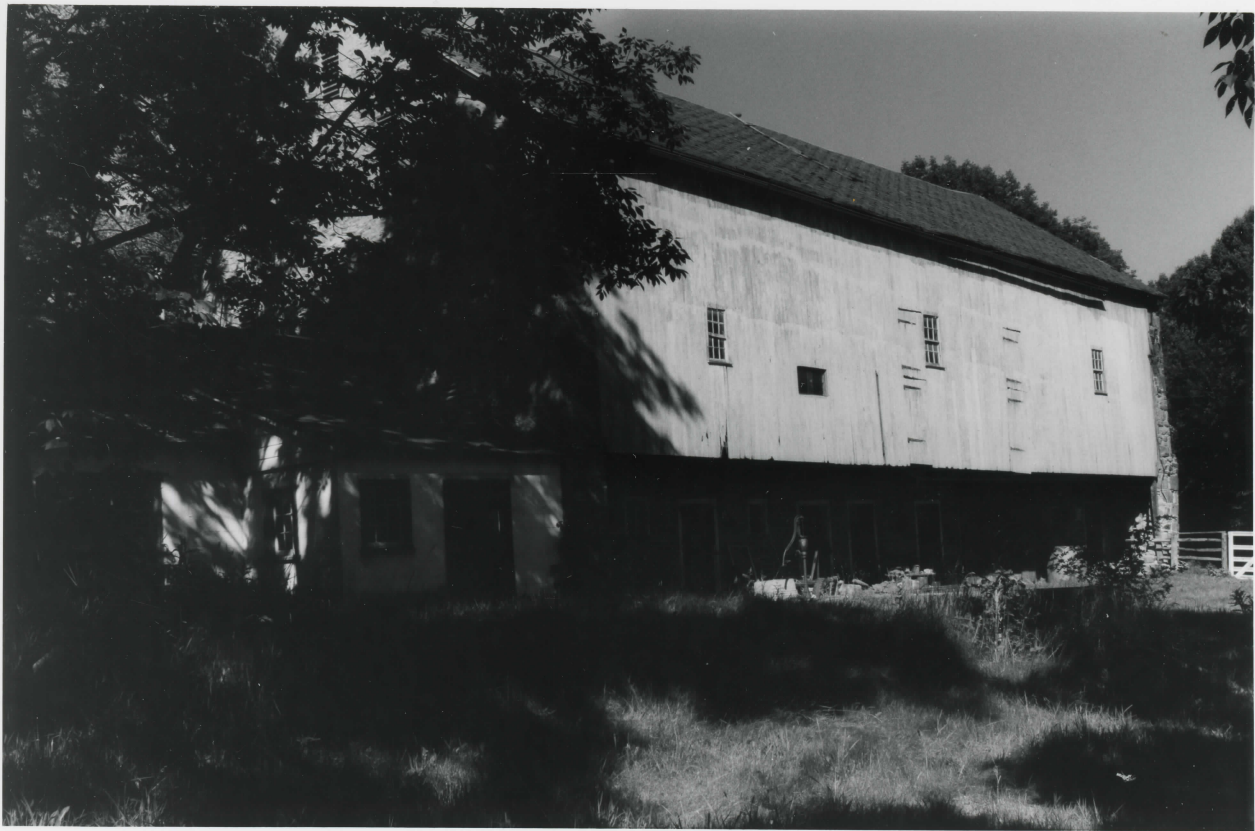
#6

6. Barn, front facade, camera pointing SW
7. Photo # 6

4. Barn: Stone bank barn, built 1806, louvered windows at gable ends, tin roof. Upper level is four bays wide with two threshing floors, and is intact. Front facade has closed forebay design with peiler eck, Dutch doors with wrought iron strap hinges, small windows with wooden grills. Stone rear end addition beside ramp extending toward road, gable roof of slate, 1839 datestone. Lower level was used for cattle. The Gehmans converted the eastern half into a cow stable in the 1930s, with concrete floor, cleaning gutters, and metal stanchions. The west half was used as a stable with box stalls added in the 1940s. One-story 1940's addition at east end, built of concrete block, includes former milk house and former chicken house.

The barn built by John S. Gehman is one of the earliest examples of its type in the county. It is classified by Ensminger as a standard Pennsylvania barn, a banked barn with forebay, having a symmetrical gable wall configuration. This barn has stone walls with louvered window openings on its gables. Its interior framing features principal rafters and staggered purlins. The fact that it is a dated example aids researchers like Dr. Ensminger in determining the evolution of barn forms in Berks and other Pennsylvania counties. Its additions, in 1839 and c.1940 are typical changes to increase storage capacity and accommodate new patterns of use. These changes do not disturb the integrity of the original structure.
